Coastal Barrier Island Breaching, Part 2: Mechanical Breaching and Breach Closure

By Ty V. Wamsley, Nicholas C. Kraus

PURPOSE: The Coastal and Hydraulics Engineering Technical Note (CHETN) herein describes case studies of the mechanical closure and creation of coastal barrier island breaches. Emphasis is on breaches that form near inlets, with examples also given of breach opening for environmental enhancement. Part 1 in this technical note series reviews the causes of breaching and measures to prevent breaching (Kraus and Wamsley 2003). Subsequent technical notes will describe models under development in the Coastal Inlets Research Program for predicting the inception and evolution of breaches.

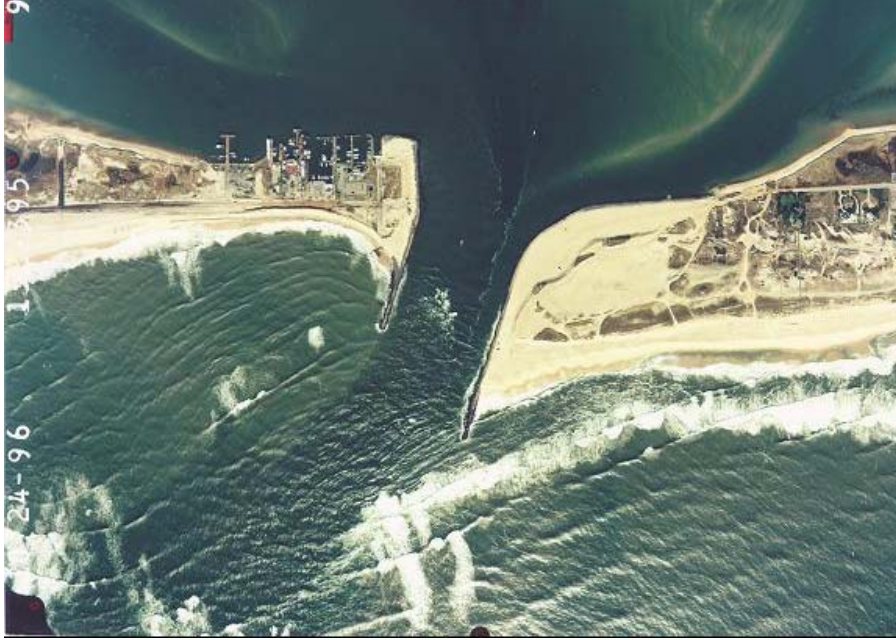
Figure 1. Shinnecock Inlet, NY, showing severely eroded downdrift beach adjacent to downdrift jetty

Figure 1 shows Shinnecock inlet in October 1996, with the western beach (left side of jetties) eroded to endanger the public road and the marina complex on the north (bay) side of the barrier island. Emergency measures have been taken by the county and town during severe storms to prevent breaching. The U.S. Army Engineer District, New York, places material dredged from the Federal channel onto the eroding beach segment as a least-cost disposal alternative.

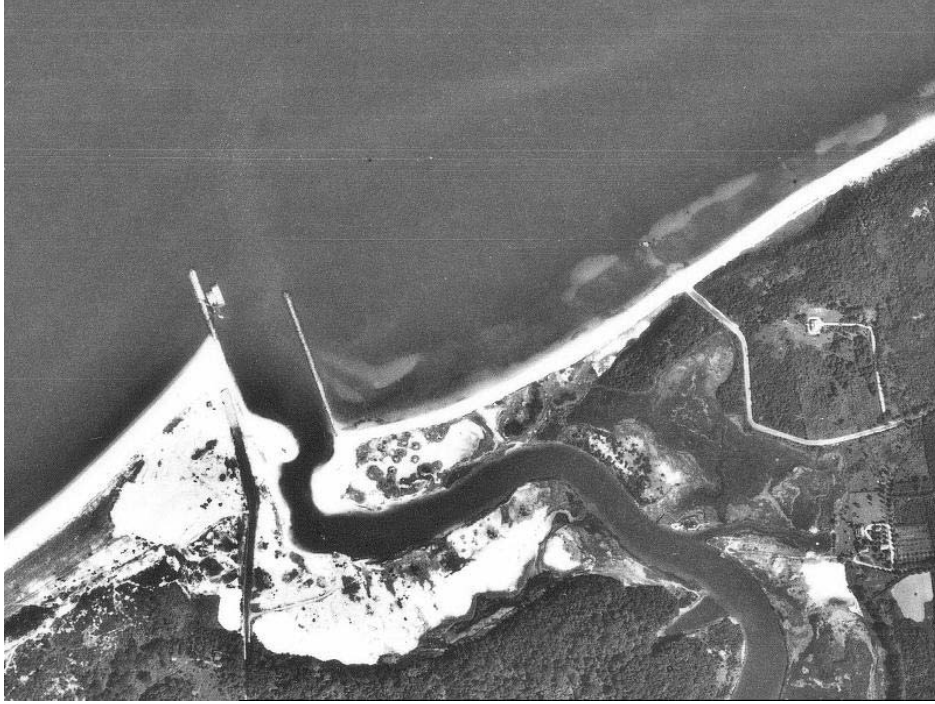
Figure 2. Mattituck Inlet, NY, with a spit encroaching from the east (from right side in the photography) through a breach in the barrier island

As another example, a downdrift breach occurred at Mattituck Inlet, Long Island, NY, which faces the Long Island Sound. Regional net transport is from west to east on this coast. The Federal jetties at Mattituck were constructed in the early 1900s. The shoreline directly east of Mattituck inlet receded rapidly during the 1920s and 1930s, and a landward breach at the base of the east jetty at Mattituck Inlet opened in or around 1935, resulting in the formation of a west-directed spit (Figure 2) at the base of the east jetty that protruded into the navigation channel. In response to the breach, the New York District extended the east jetty landward in 1946, and material dredged during this time was placed onto the beach directly east of the inlet, the first known beach nourishment for this location (Morgan et al. 2005).

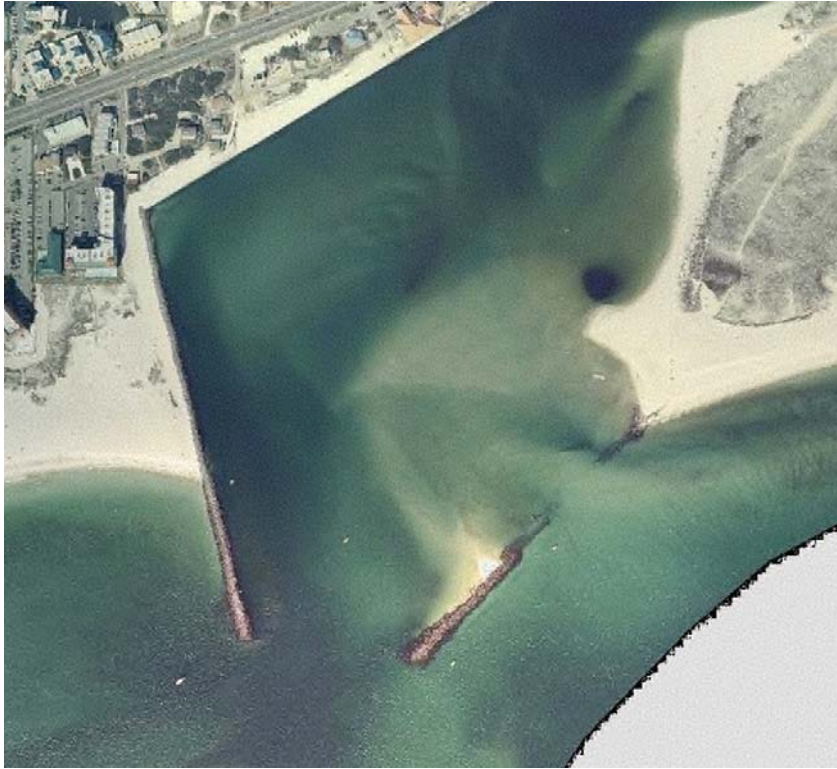
Figure 3. Perdido Pass, FL, February 2003, with spit on right side protruding into the channel behind the weir jetty

Perdido Pass, FL, is an example of breaching that occurs on the updrift side of the inlet because the jetty does not extend sufficiently landward (Figure 3). The updrift (east) beach adjacent to the east jetty is monitored and filled by the U.S. Army Engineer District, Mobile, to prevent further opening of breaches that occasionally occur there, such as after 2004 Hurricane Ivan.

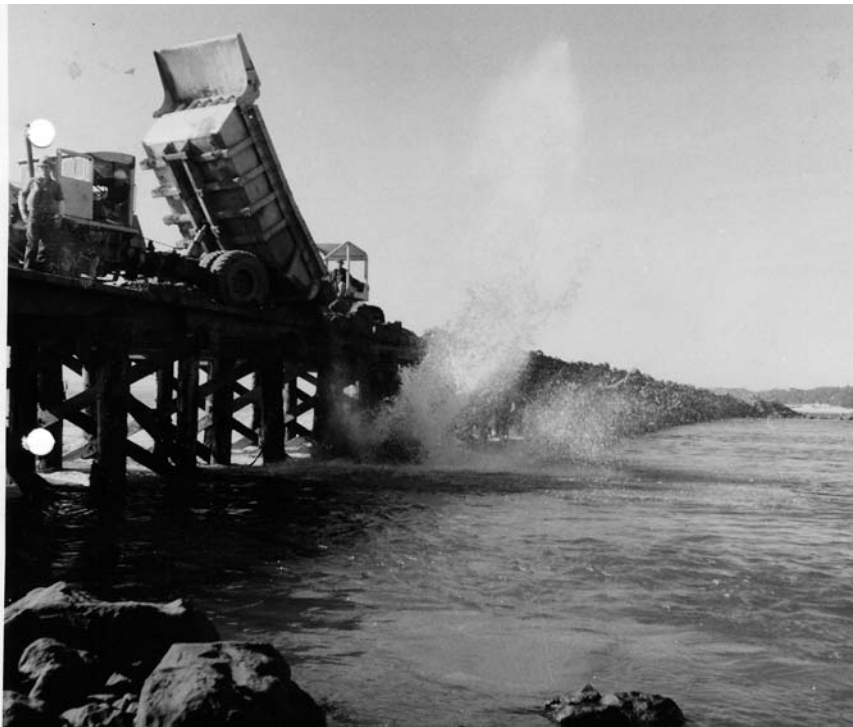
Figure 4. Rock fill by conventional end-dump method (Henshaw 1956).

The rock fill was placed across the breach channel from the mainland to the north wing spit. The first stone was placed in May of 1956. The rock fill was built with conventional end-dump methods (Figure 4). A dozer made the final placement of the rock. It had a top elevation of 20 ft mllw and a top width of 15 ft. The side slopes were 1 on 1-1/2. Eighty percent of the rock on the seaward side of the fill weighed at least 5,000 lb, and none of the stone on the seaward side weighed less than 3,000 lb. Toe blankets 6 ft wide and 50 ft wide were provided on both the seaward and bayward sides of the fill.

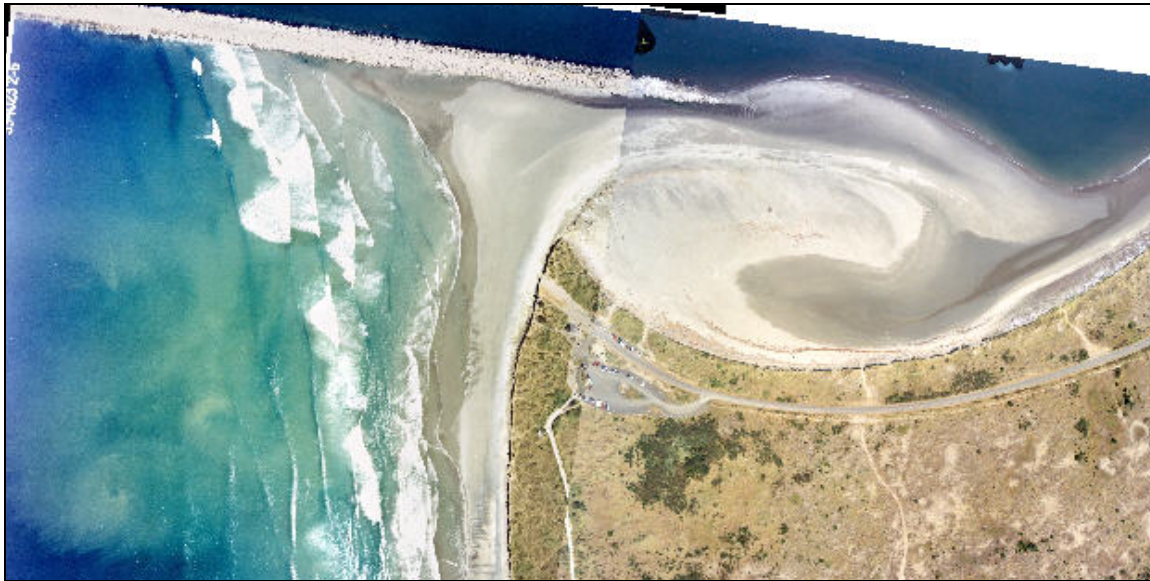
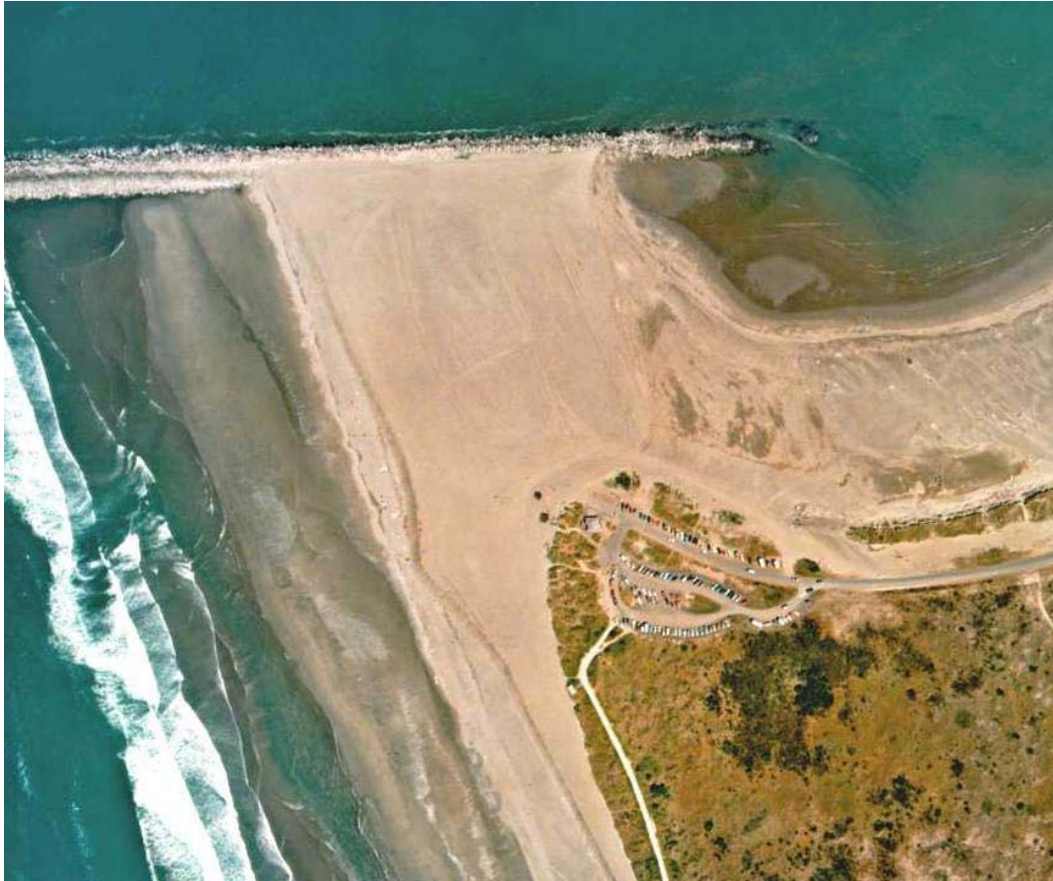
Figure 7. Grays Harbor Washington breach area.

a. Before closure, August 1994.

b. After closure, September 1995. Closure was completed in December 1994.

The sand was pumped unconfined on the upland adjacent to the breach and stockpiled until a sufficient volume was available to close the breach. The breach was closed by bulldozing the stockpiled material into the narrowest part of the breach. The closure operation began around low tide, and the initial closure was completed by high-tide. The sand was pushed from the beach, across the breach toward the jetty. Maximum current velocity through the breach at the time of closure was about 6.5 ft/sec, but there was little flow through the breach at low tide. With the initial fill cross-section in place, the same technique was applied to complete the fill to the final design template. The breach fill was completed on 7 December 1994 with 600,000 cu yd of sand dredged from the navigation channel. Photographs in Figure 7 show the breach area before and after closure.

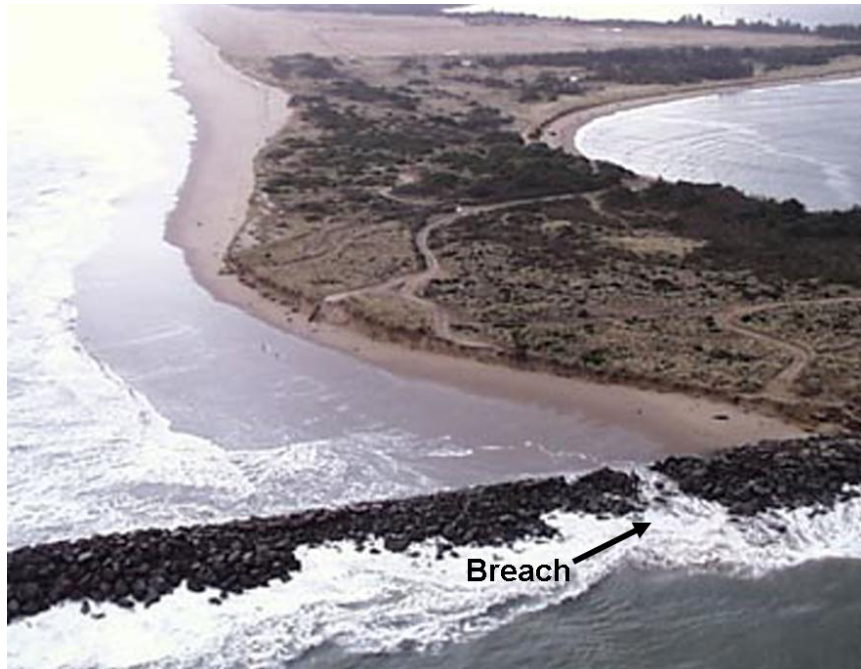
Figure 8. Coos Bay, Oregon breach of the north jetty (Hays et al. 2003).

Similar to Grays Harbor, the shoreline on the bay side of the north spit receded as a result of inner bank erosion following the construction of the north jetty. The ocean shoreline also receded as a result of transport directed offshore near the north jetty. In addition, the navigation channel migrated to the north, eroding the interior shoal that supported the base of the jetty and exposing the landward terminus of the north jetty to increased wave attack. Return flow from wave runup on the shoreface and overtopping of the north jetty formed runnels along the base of the jetty. These factors weakened the north jetty and culminated in a breach of the north jetty on 8 November 2002 during a storm with offshore waves in excess of 8.7 m in height and 17-sec period. The landward end of the jetty was breached, not the barrier spit (Figure 8). The waves approached from the west-southwest and directly attacked the landward terminus of the north

jetty. The breach in the jetty was approximately 4 m wide. A complete discussion of the jetty breach and closure operation is given by Hays et al. (2003).

Following the breach, the beach adjacent to the north jetty eroded, losing an estimated 40,000 cu yd of sand through the breach and into the entrance. The beach profile elevation was lowered approximately 6.5 ft. Tidal flow through the breach widened the damaged area in the weeks following the storm. Approximately 40 days after the jetty breached, the opening had widened from an initial 13-ft width to about 245 ft. The jetty breach caused rapid shoreline recession and, if not closed, could have resulted in a breach of the barrier spit.

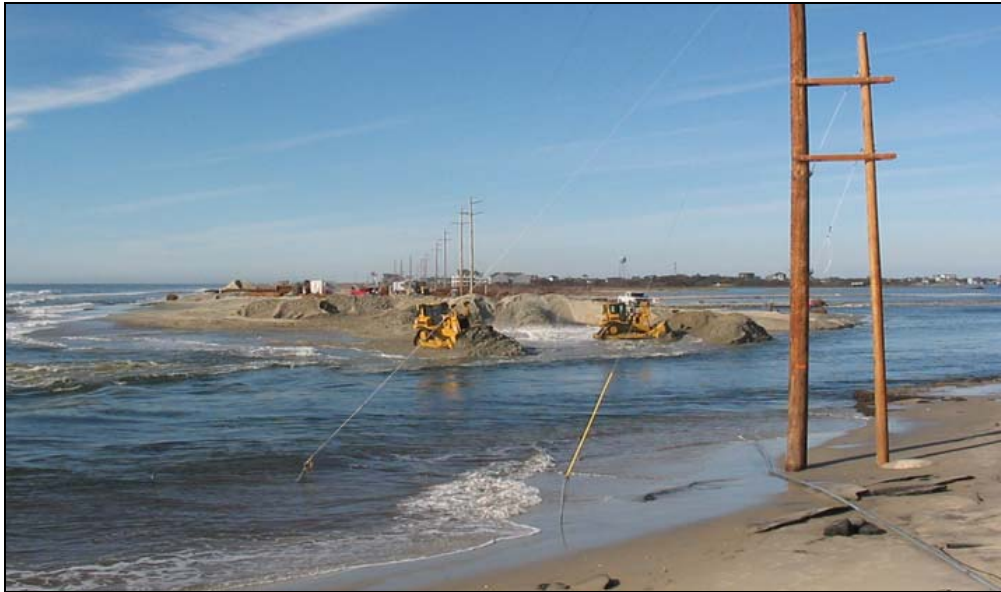
Figure 9. A view of the first attempt to complete the closure looking to the west from the eastern bank of the breach (Wutkowski 2004).

facilitate rapid advance of the fill and close the remaining portion of the breach, a narrow mound of sand was bulldozed across the breach at slack tide to prevent water flow through it (Figure 9). Once the flow of water was stopped, additional material was added to the narrow mound to fill the remaining design template without the losses caused by the tidal current. The final closure began at high tide and was completed at low tide, thus allowing several hours for the berm to be widened the berm before wave runup began to erode the berm at higher water levels. No material was stockpiled in advance, but a 2,300 cy yd/hour dredge production rate provided a sufficient source of sand to build a small dike across the remaining breach. It was observed that the final closure would have been facilitated by stockpiling sand on the bank opposite the dredge pipe outlet. The stockpile would have allowed sand to be pushed from both sides of the breach.

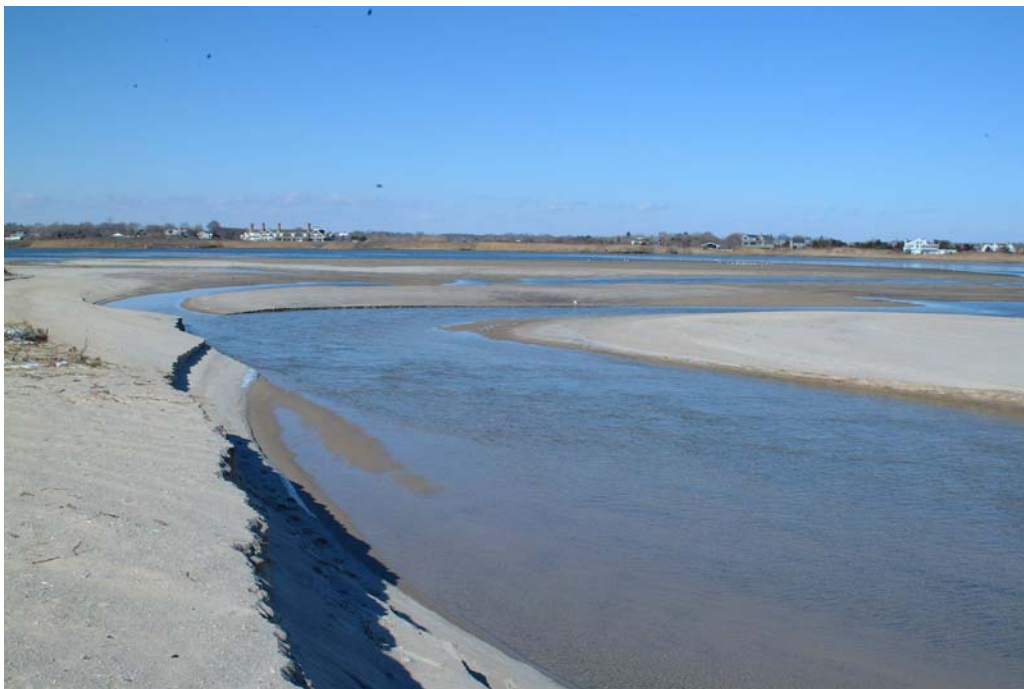
Figure 10. Breach cut at Sagaponack Pond on Long Island (looking toward pond), 4 March 2005.

Coastal ponds on the Atlantic coast. Coastal ponds on the Atlantic coast are often mechanically breached for environmental reasons and to reduce the risk of flooding. On the south shore of Long Island, NY, Mecox, Sagaponack, Wainscott, Georgica, and Hook are all brackish ponds that are breached, typically annually or more frequently, to alleviate flooding and improve water quality. The ponds are breached by digging a pilot channel with conventional earth-moving equipment from the ocean toward the pond and from the pond toward the ocean, leaving a sand plug in a convenient location to be excavated. The plug is removed at low tide and preferably during a period of low waves to prevent premature closure of the breach by longshore transport. Figure 10 shows a recent breach cut made at Sagaponack Pond. The breaches are left unattended to close naturally by infilling through longshore transport. As a breach closes, the ephemeral ebb shoal created by the opening may weld to shore and contribute to closure and beach healing (Kraus et al. 2002). Smith and Zarrillo (1988) document the natural closure of Mecox Pond after mechanical opening.

Typically, pond opening is conducted during time of low tide and moderate to calm wave conditions. In this way, water will ebb from the pond rapidly, increasing the width of the breach, while minimizing formation of a flood shoal. An increase in volume of the flood shoal decreases pond area and removes sediment from the beach.
